# Staying Compliant with NFPA 70B Standards

Written by: ITM Instruments, Sept 10th, 2024

## Key Considerations for Businesses

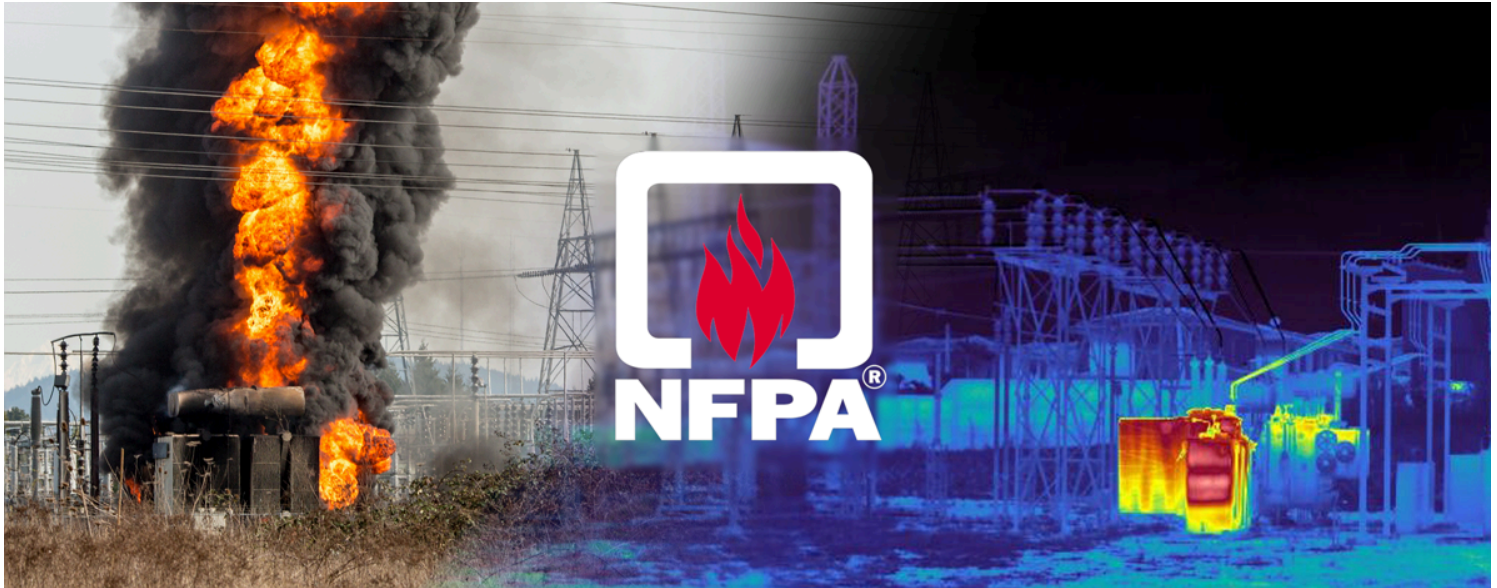
Figure 1: Thermal Imaging in Industrial Plant for Prevention

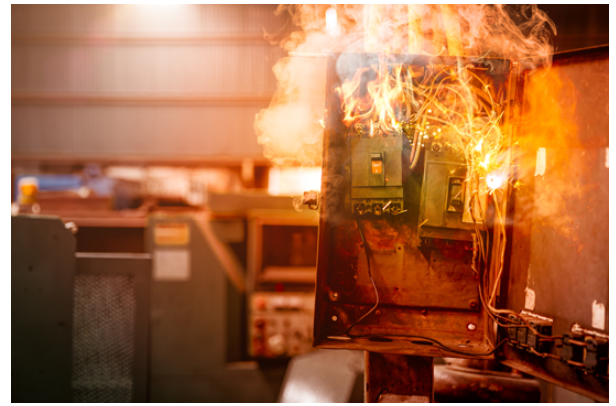
*Figure 2: Even the Smallest Temperature Variation Can be a Sign of a Potential Fire*

One of the primary updates in the 2023 NFPA 70B standards is the emphasis on accurate thermal imaging. Companies now need access to thermal imaging cameras that can precisely measure the  $\Delta T$  (temperature differential) of similar electrical components under similar loading conditions. This capability is essential for identifying potential hot spots, which could indicate underlying issues such as loose connections, overloaded circuits, or insulation failures.

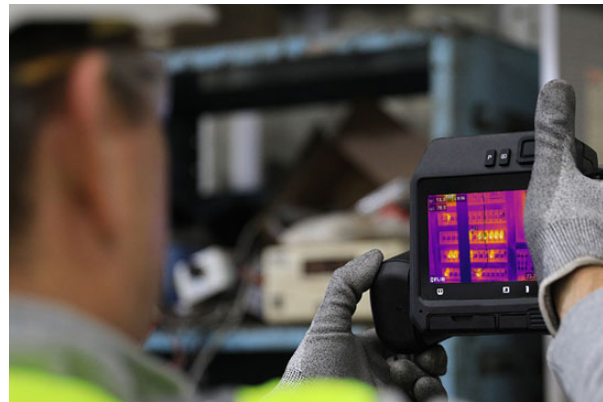
*Figure 3: Proper Application of Thermal Imaging Camera*

This training should cover not only the technical aspects of using the camera but also the underlying principles of thermal imaging. Inspectors need to understand the impact of factors such as emissivity, reflectivity, and ambient conditions on their readings. Additionally, they must be able to identify and measure the temperature differential between the target and a reference area accurately, as required by the new standards.
